**PERDIDO GROUNDWATER CONTAMINATION  
SITE  
EPA ID: ALD980728703**

**PERDIDO, BALDWIN COUNTY, ALABAMA**

**SECOND FIVE-YEAR REVIEW REPORT  
FOR  
OU-1, GROUNDWATER OPERABLE UNIT**

**Prepared By:  
Mobile District  
U.S. Army Corps of Engineers  
P.O. Box 2288  
Mobile, Alabama 36609**

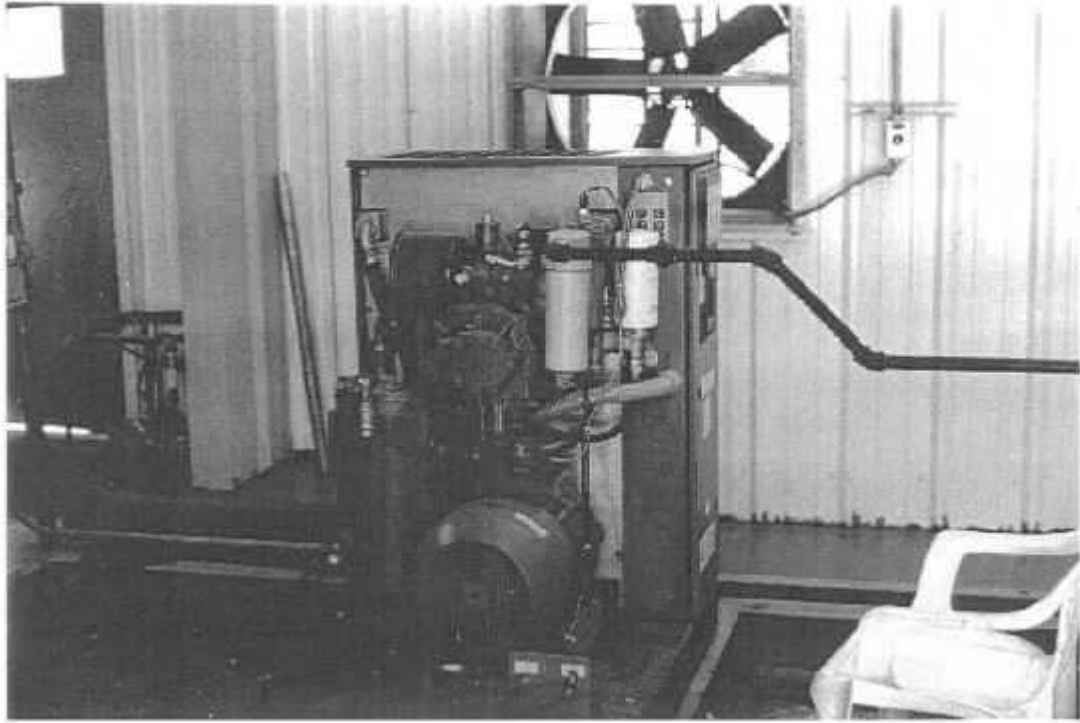
AIR COMPRESSOR FOR BIOSPARGE WELLS

This plant is very well maintained. The equipment is clean, well serviced and operating as design. The air stripper and air compressor that were high maintenance items have been replaced. The plant is inspected daily and the inspection details are recorded. The records are reviewed to make sure that required maintenance such as pump and well screen cleaning and servicing is performed as required. If this level of O&M effort is maintained the plant should remain functional and effective for several additional years.
